Chapter 5

Identify and Select Solutions

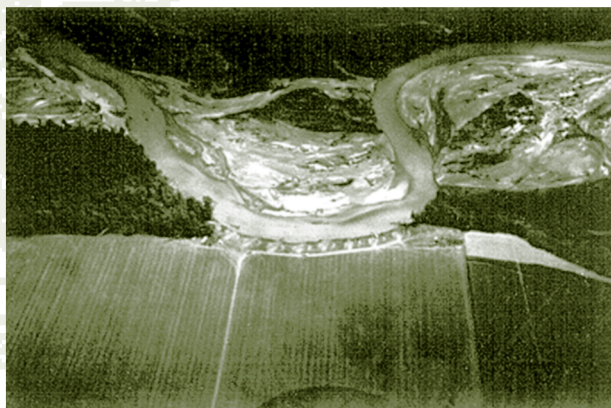
Figure 5-4. Plan view of erosion on the Nooksack River.

The primary mechanism of failure for erosion at the two Nooksack River sites was toe erosion. There were two site-based causes for toe erosion: bend scour and a reduced vegetative bank structure associated with land clearing for agriculture. Bend scour was the dominant cause, which occurs when the erosive force shifts from the bed of the channel to the outer corner of the channel as it encounters a bend. A secondary mechanism of failure was the potential for an avulsion caused by natural aggradation in this river reach.

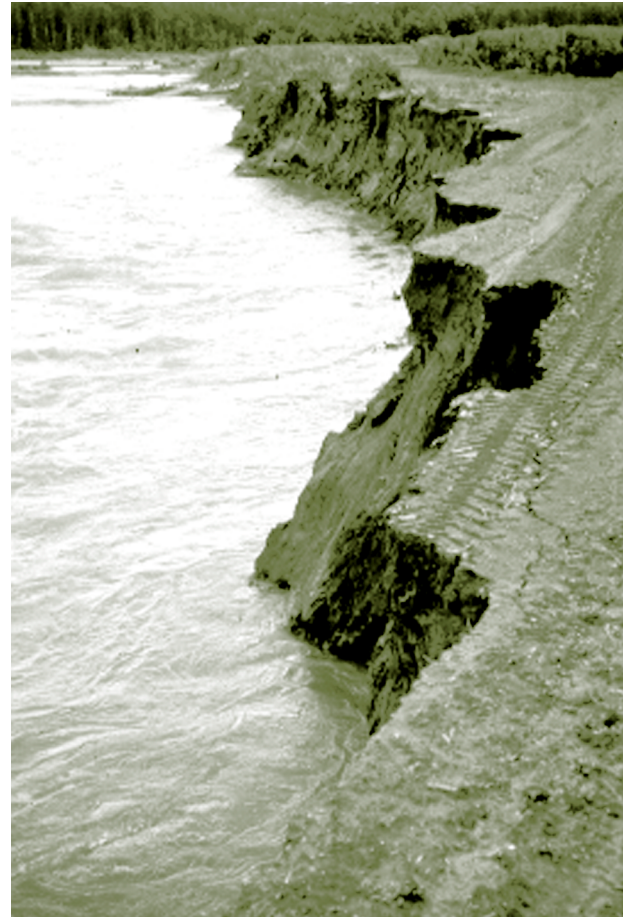
Figure 5-5. Ground view of erosion on the Nooksack River.

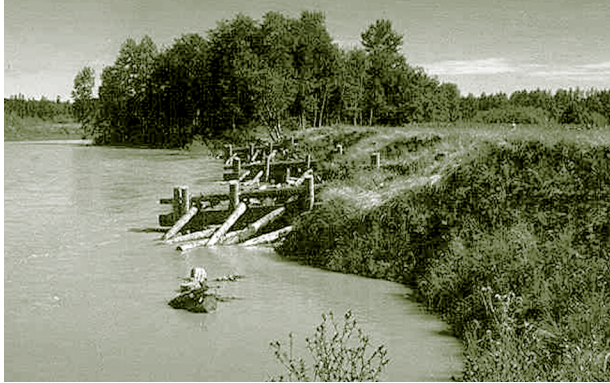
Figure 5-6. Log groins on the Nooksack River.

Bank treatments used in this project included groins constructed of logs that were cabled to wooden piles (see *Figure 5-6, next page*); groins consisting of a rock key and foundation with an upper surface of concrete doloes (see *Figure 5-7, next page*); and groins built entirely of rock. The all-wood, log-and-pile groins were used where hydraulic analyses indicated they were durable enough for site conditions. The other site had higher-flow energy and received the dolo groins. Designs for both sites included cut-back trenches to prevent flanking of the groins, which could result in excavation of the barb keys by erosion. Both site designs also incorporated woody debris anchored to (or built into) the groins and banks. To promote bank stability, all banks were groomed back to a 2:1 slope. To protect the upper banks and to facilitate the rapid establishment of native riparian species, both designs also included detailed revegetation plans.

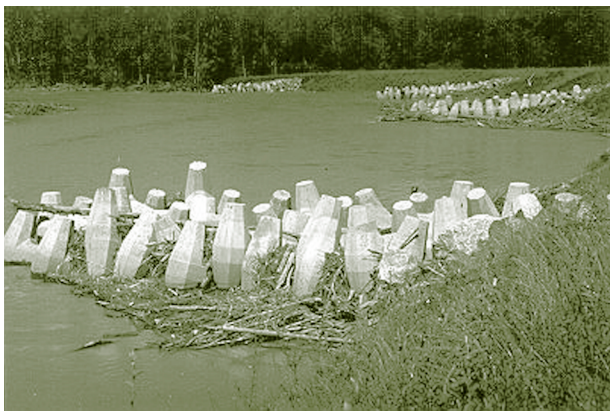
Figure 5-7. Concrete doloes with woody-material recruitment on the Nooksack River.

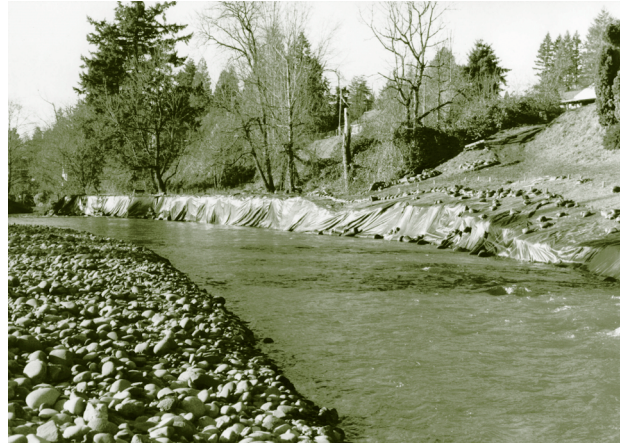
Figure 5-8. Eroding bank on Salmon Creek.

This case-study description focuses on one particular site, about 650 feet in length, where the streambank was severely eroding into adjacent properties. An expansive gravel bar was directing the channel thalweg toward a steep slope with fine sediments, and single-family residences located at the top of the slope were at risk (see [Figure 5-8](#)).

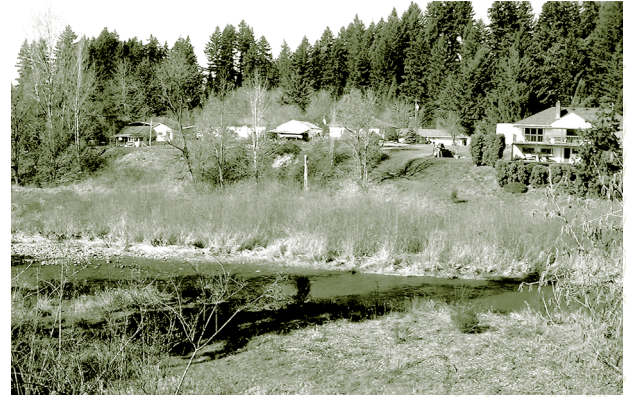
Figure 5-9. Channel realignment, vegetation plantings and bank reshaping on Salmon Creek.

The bank-protection techniques used at the project site included channel realignment, high-flow channel creation, and vegetative plantings (see *Figure 5-9*). The six-foot-high, vertical right bank was protected by relocating gravel bar material and realigning the channel toward the left bank. Photographic records of channel changes within the reach were used to select the most stable channel configuration. Next, material was excavated to form a high-flow channel upstream to increase conveyance and to provide some relief during flooding. It also decreased erosive potential along the newly created right-channel boundary. Finally, the slope of the eroding bank was reduced, and the roughness of the bank was promoted by planting willow clumps salvaged from the high-flow channel excavation. These treatments were combined with woody-debris placement in off-channel areas and woody plantings to promote bank stability and habitat.

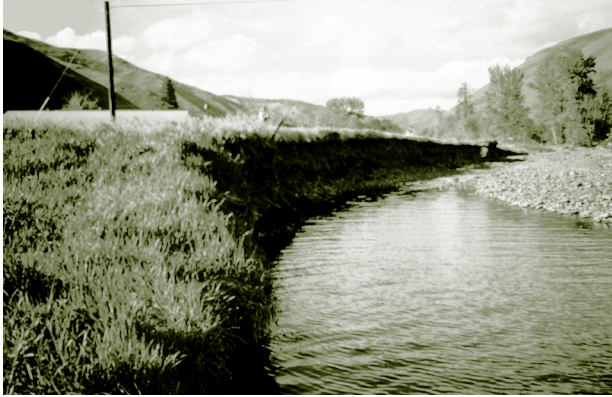
Figure 5-10. Left-bank erosion on the Tucannon River.

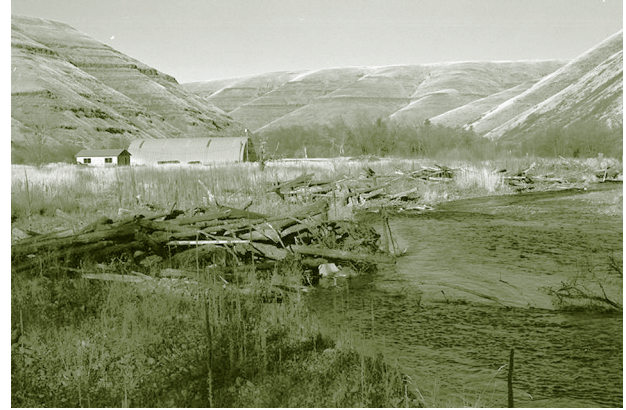
Figure 5-11. Engineered log jams on the Tucannon River.

Figure 5-11 and *Figure 5-12* show the project two years after construction. The engineered log jams were modeled after a technique developed by T. B. Abbe and D. R. Montgomery.¹ Key pieces were made by cabling several trees together and cabling four, three- to four-foot-diameter boulders to each piece. The boles of key pieces were buried in gravel-bar sediments up to the rootwad, against which smaller logs were racked. As a factor of safety, several four-foot-diameter boulders were placed on the rack for additional ballast.

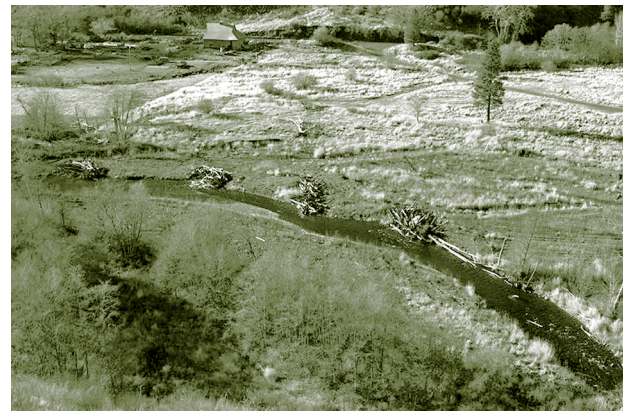
Figure 5-12. Engineered log jams on the Tucannon River.

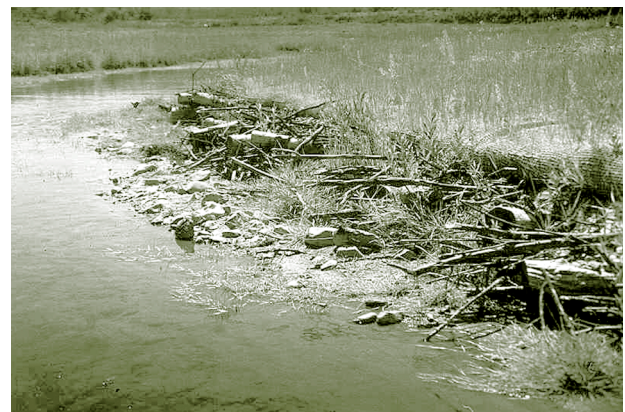
Figure 5-13. Gravel wrapped in biodegradable fabric serves as a deformable bank.

Deformable bank protection includes a biotechnical bank-protection treatment for the portion of bank above the water surface. In some situations, this level of protection is sufficient. Where below-water protection is required against shear forces (where the native bed and bank materials are readily eroded), deformable bank toes might include those made from small wood and gravel, or from gravel wrapped in biodegradable erosion control fabric as shown in *Figure 5-13*.³ In these applications, the gravel or cobble approximates the size of the largest gravel or cobble in the stream. Once the wood or fabric decays, the gravel or cobble can be gradually eroded. By that time, the above-water portion of the bank will be vegetated, resisting erosion.

Deformable bank-protection measures do not impinge on natural, long-term, meander-migration processes and, thus, do not exacerbate upstream and down-bank instability as do permanent stabilization measures.
